Resolving Functional Obsolescence

Securing the Future of Oregon's
Pioneer-Era Properties

Prepared by Paul M. Falsetto, Architect, and Venerable Group, Inc., for Restore Oregon

March 2015

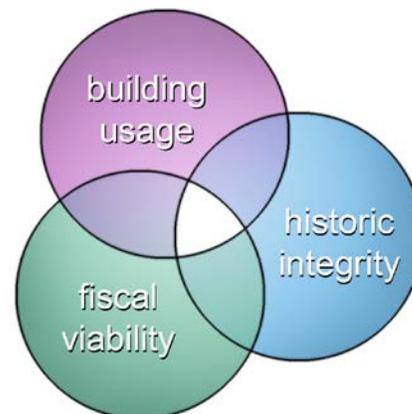
The intricate relationship between use, economics, and historic preservation

The overlap between what a building can accommodate without diminishing its historic character and what uses the market can support is where truly sustainable preservation exists.

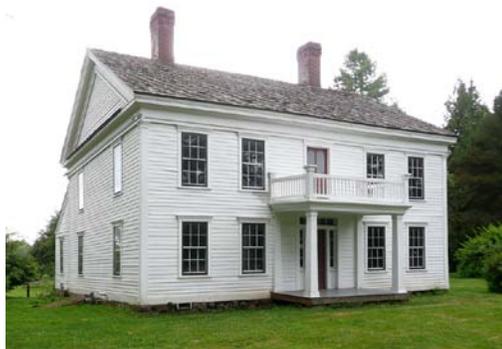
Current image of the main facade

Physical Integrity & Condition Integrity Interior: Good Integrity Exterior: Good Condition Interior: Good Condition Exterior: Good	<ul style="list-style-type: none"> Building clearly communicates its history and authenticity, which will be a draw for guests. Building well maintained by Owner, and in good enough condition that renovations are feasible. 	<ul style="list-style-type: none"> Will need constantly dedicated funds allocated for maintenance. Respecting integrity/authenticity could constrain certain upgrades that are typical in overnight accommodations.
Rehabilitation Work Scope		Proposed use: hostel-type accommodations
Exterior <ul style="list-style-type: none"> Examine exterior wood for rot or damage. Patch or repair, and repaint Roof appears to be in good condition, with usable life. Provide an ADA pathway from parking to rear of building, provide ADA ramp and stair located at back. Enclose back porch for bathroom. Ensure good operation of windows. Examine condition of chimneys, repoint as needed. 	Interior <ul style="list-style-type: none"> Add a 3/4 bathroom at the first floor, and two at the second. Add plumbing for the kitchen, and provide counters, cabinets, and appliances for basic food service. Examine the electrical system. Provide ADA handrail at stairs. Provide 2nd floor ceiling insulation. Refinish the floors, repaint the interior. Update the smoke detection system. Provide furnishings for all rooms. Conduct seismic upgrades in basement. 	Economics <ul style="list-style-type: none"> Rehabilitation costs range from \$85,000-\$225,000. Metro funding assumed; possible Preserving Oregon Grant. B&B use is a good fit with building, market demands, and may provide modest income. Further analysis is needed to determine more specific financial outcomes.

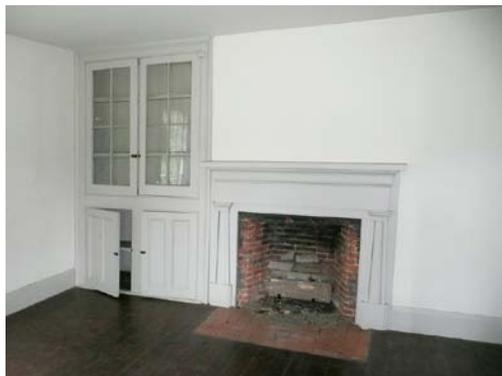
The front corner room, with casework and fireplace

The house features an efficient layout with good-sized rooms at each corner. Access via stairs to two entry porches currently makes the house inaccessible for people with disabilities. Metro will want to make the first floor accessible, which would require the construction of a ramp best situated at the rear of the property. The second floor could be excused from ADA compliance if it contains uses redundant to those of the first floor.

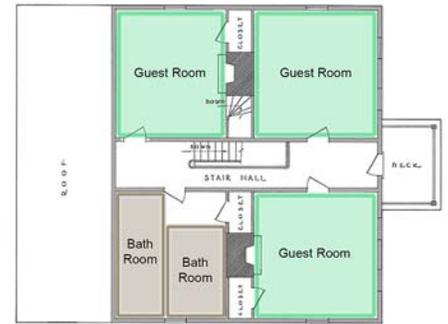
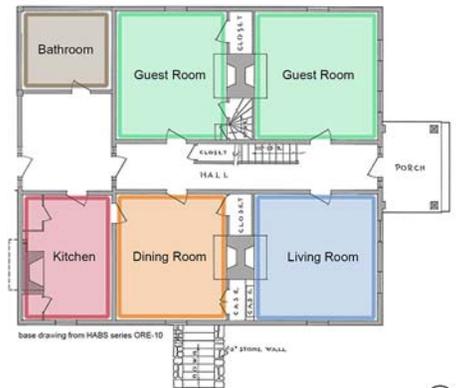
Proposed Use 'A': hostel

Second Floor Plan

First Floor Plan

The exterior rehabilitation work scope would involve conducting exterior repairs as required, installing a new ADA ramp, and enclosing the back porch. The interior work scope involves the installation of plumbing for a serving kitchen and bathrooms; refreshing of floor, wall and ceiling finishes; providing a smoke detection system; and insulating the attic. All necessary furnishings would be included.

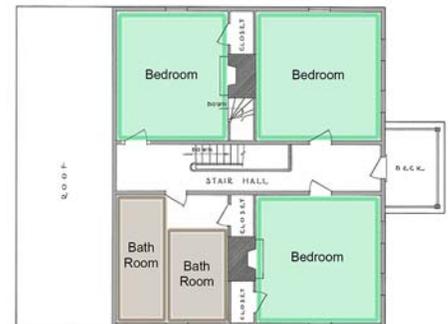
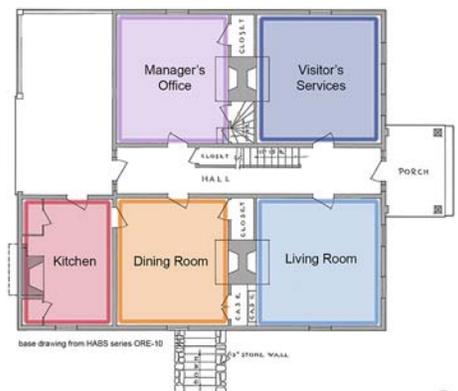
Proposed Use 'B': welcome center

Second Floor Plan

First Floor Plan

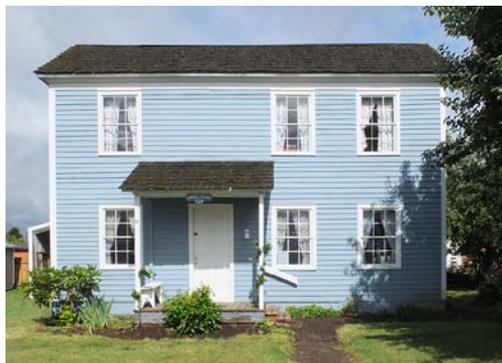
Current image of the main facade

The roof is due to be replaced and there have been concerns with the south wall, which shows a bulge in the area of the second floor line. This could be representative of a widespread issue, as the building reportedly has no sheathing between the exterior siding and the framing. At some point insulation was installed at the exterior walls, and that insulation could be holding moisture against the wood structure, causing rot and encouraging insect damage. All exterior walls should be examined to determine their condition.

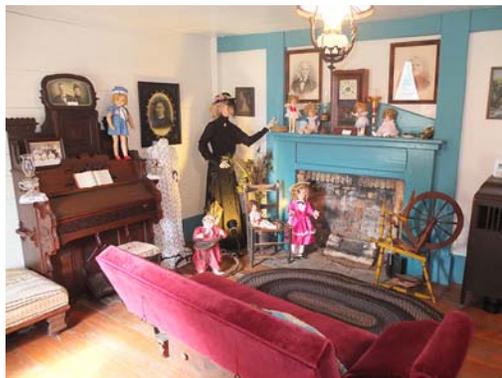
The living room, with full furnishings

The house is fairly simple in layout, with the largest rooms on the first floor at opposite corners (the living room and the kitchen), and smaller rooms at the remaining corners. A tight stairwell leads to the second floor, consisting of a larger bedroom located immediately above the living room, and a smaller bedroom, opposite. The building is in relatively good condition, though there are exterior elements that require focused examination.

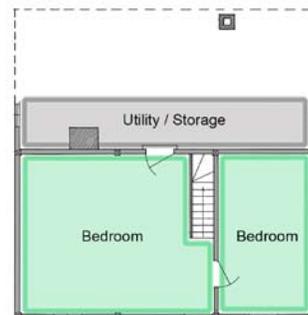
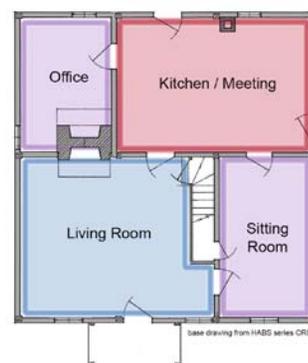
Proposed Use: house museum

Second Floor Plan

First Floor Plan

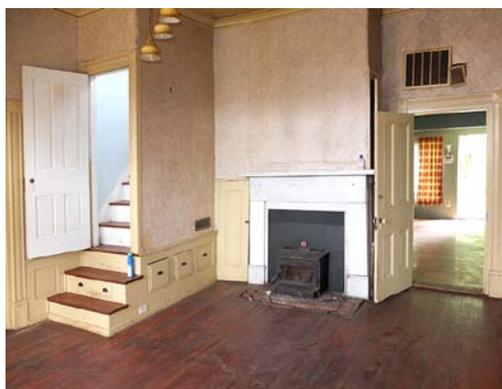
The central hallway

The house is secure and weather-tight, but in need of rehabilitation to be made livable. At the first floor, the house contains large rooms at the corners, with a generous main hall opening onto the impressive portico. The second floor is accessed via a tight stair and into a large room the size of the main hall immediately below, and this room provides access to the deck portion of the portico.

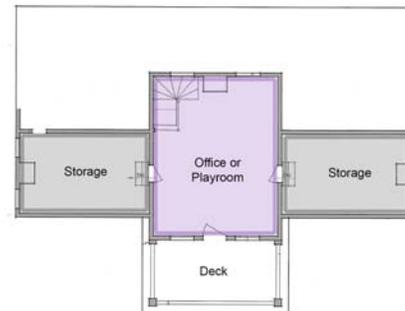
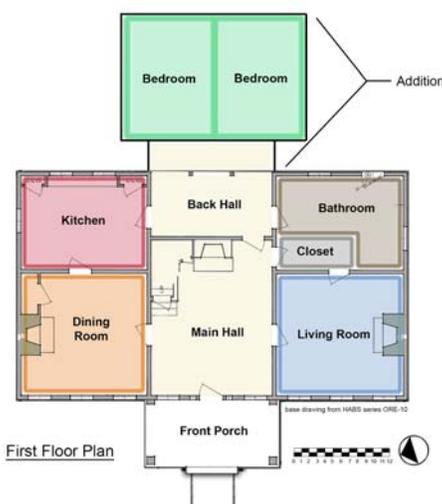
Proposed Use: private residence

Second Floor Plan

First Floor Plan

Rehabilitation Work Scope	Scope of work: renovate for residential use, provide addition	
Exterior	Interior	Economics
<ul style="list-style-type: none"> Examine original exterior wood for rot. Patch, repair, and repaint. Remove non-historic siding at rear and re clad to match original. Remove cladding of front porch piers, examine structure underneath. Will likely need to strengthen this system. Explore foundation condition, and repair as needed. Repair all exterior doors, provide new hardware. Ensure good operation of windows. Improve pathway to building. 	<ul style="list-style-type: none"> Patch and repaint interior wall finishes. Add a full bathroom on the main floor. Add a new kitchen, and provide cabinets, counters, and appliances. Examine the electrical system of the house and amend as needed. Examine the furnace and ducts for condition and effectiveness. Refinish the floors. 	<ul style="list-style-type: none"> Rehabilitation costs range from \$115,000 to \$225,000. HUD 203(k) loan should be considered. If current owner donates to preservation group, the property can be sold at below FMV to help make rehab financially feasible. Easement should be in place to protect property in perpetuity. Preliminary research indicates property may be worth \$275,000 when fully rehabilitated to a high standard, with additional living space.

The exterior of the house requires repair in locations and repainting. The non historic siding at the rear is to be removed and re-clad to match the original siding.

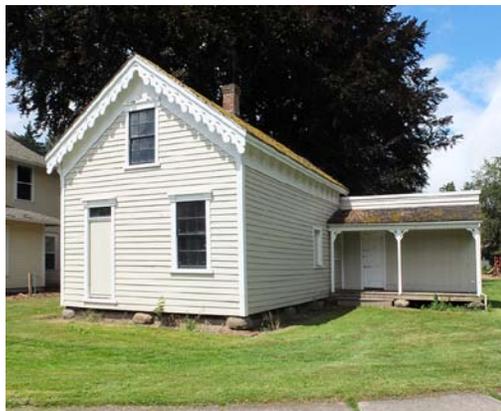
Current image of the main facade

The two-story main building is intersected at the rear by a single-story wing with a covered porch. The building was constructed as a "plank house," a technique that uses wood planks as the principal wall structure which also doubles as the interior finish surface. The challenge of this construction method is that the exterior wall provides no cavity for insulation or the routing of utilities.

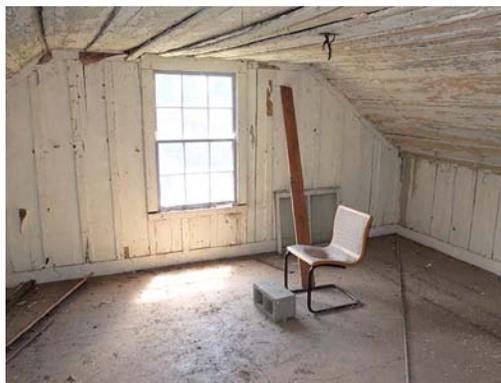
The second floor, at the front gable end

The interior of the Gaylord House is in poor condition, though some original elements are extant. As part of a rehabilitation project, all utilities will need to be routed to the house, and full mechanical, electrical, and plumbing services provided.

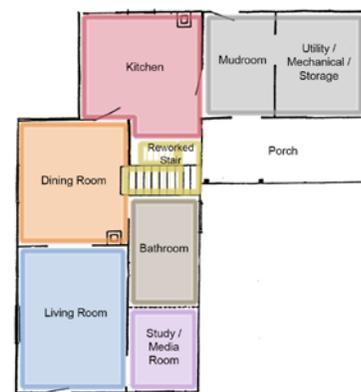
base drawing from Tiedale, 1983

First Floor Plan
