## Inspection Report

**Property Address:**  
1925 First Street  
Columbia city Oregon

**MHI Services Inc**

| <b>Date:</b> 4/19/2015 | <b>Time:</b> 10:00 AM | <b>Report ID:</b> 15143 |

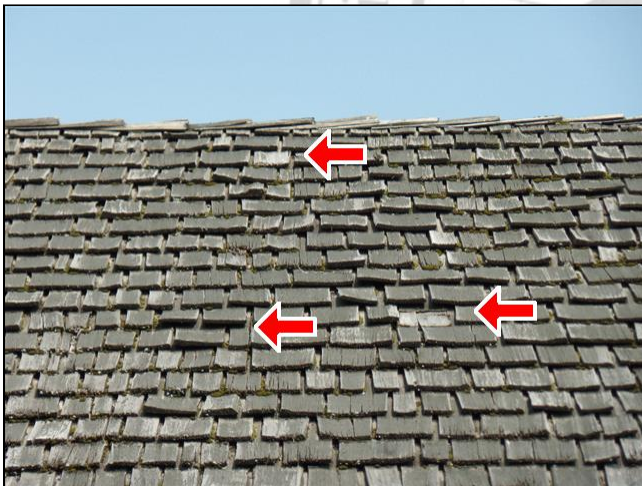
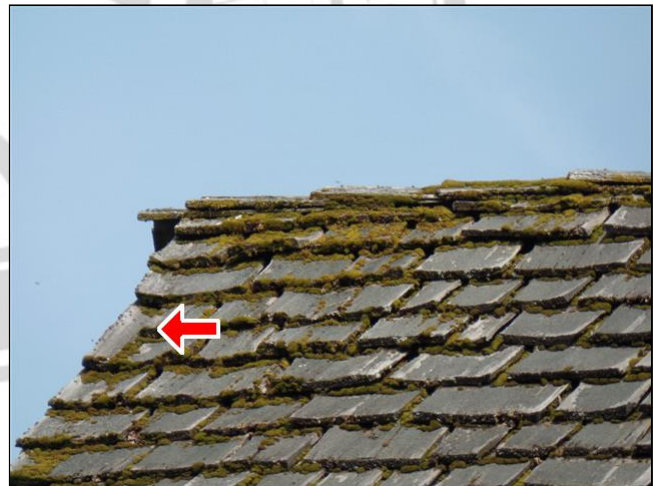
**1.0** Wood shakes show deterioration including missing and curled shakes recommend a licensed roofing contractor evaluate entire roof for needed repairs

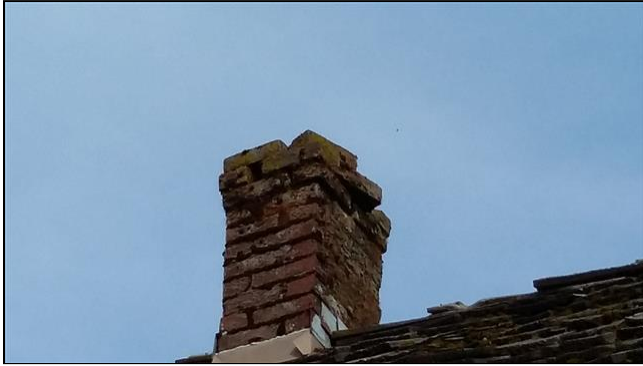
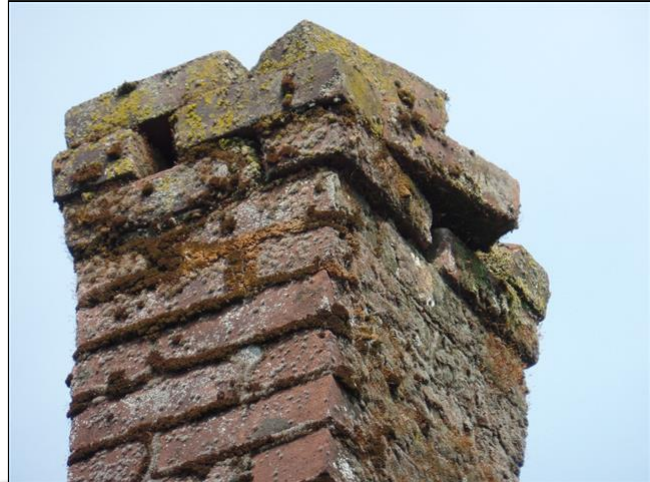
1.2 Chimney brick deterioration on both chimneys, chimney on West End of building unsafe and needs repair recommend a licensed chimney Contractor evaluate both chimneys for all needed repairs

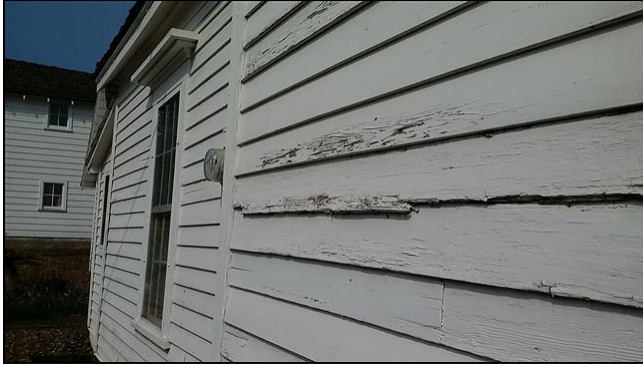
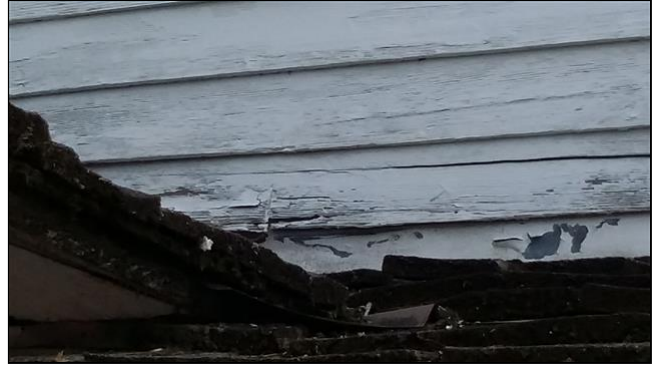
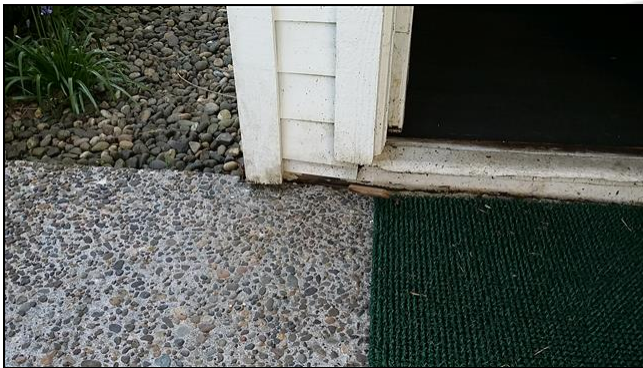
**2.0** Horizontal wood siding shows deterioration mainly on south side of building recommend a licensed siding contractor evaluate for needed repairs or replacement

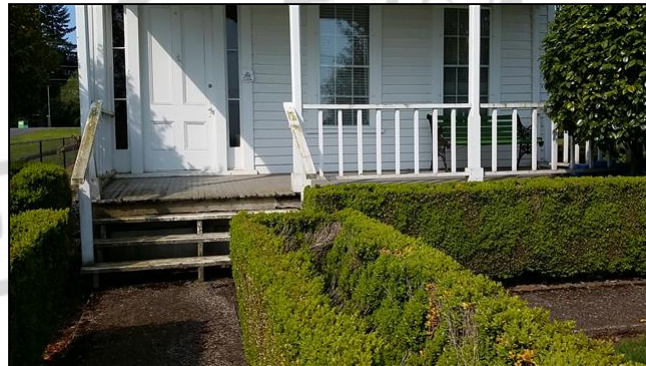
2.1 Item 1(Picture)

**2.1 (1)** Porch slopping to the southeast corner.

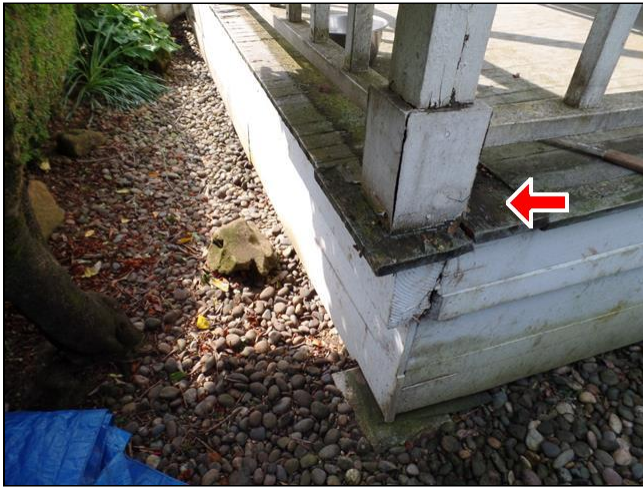
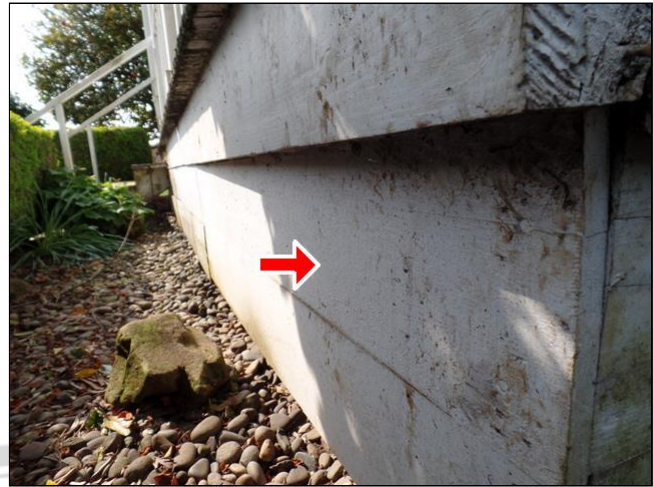
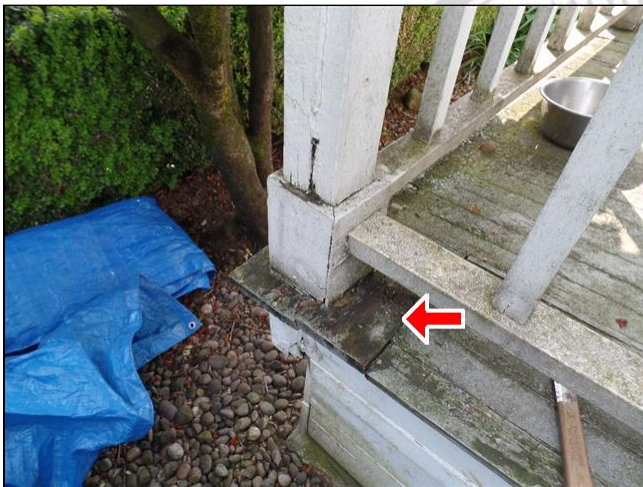
2.1 (2) Front porch and porch covering support post on right side(viewed from the front) has wood rot and floor movement. Lower portion of cladding appears to have settled under decking. This issue needs further inspection,evaluation and repair by a licensed contractor.

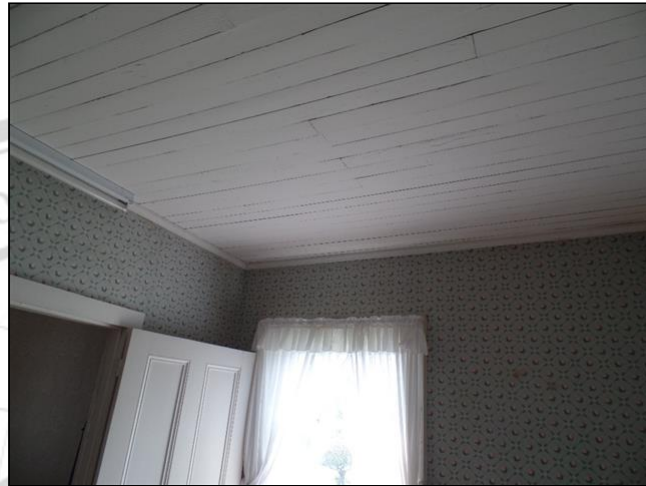
3.0 Item 1(Picture)

**3.0** Noted a large amount of ceiling movement(sagging) viewed from the main floor. I am unable to determine the cause of this issue therefore a licensed contractor needs to evaluate for all needed repairs.

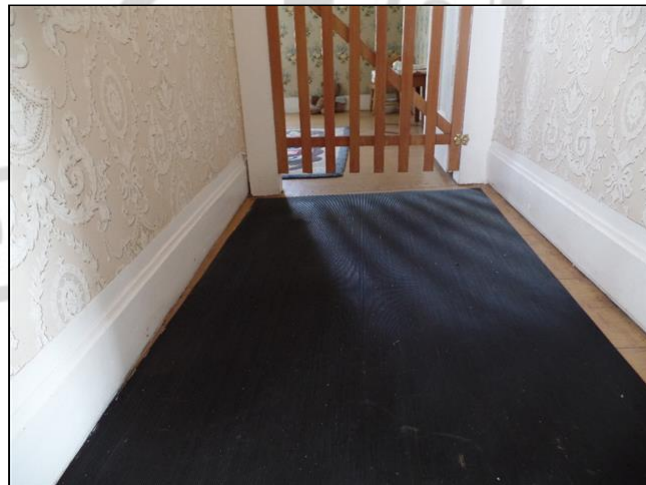
3.2 Item 1(Picture)

**3.2** Slopping floor structure due to settlement, Recommend a licensed contractor evaluate for all needed repairs.

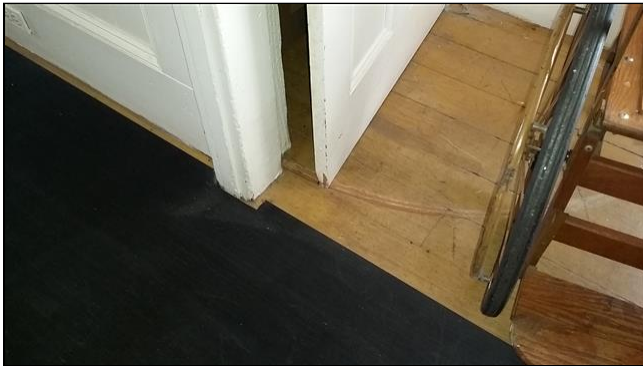
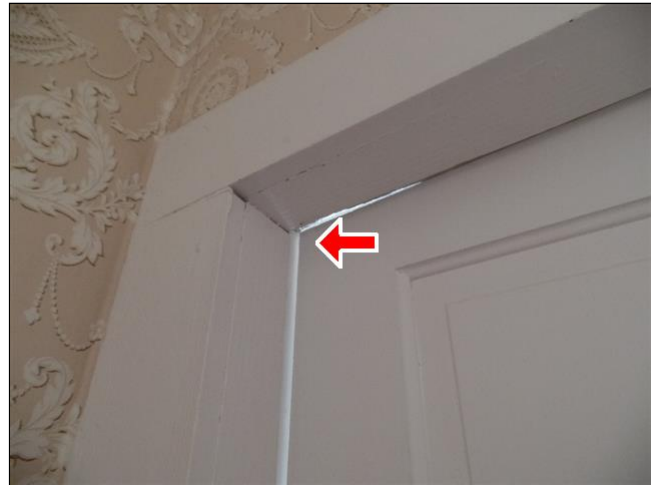
**3.3** Many doors are out of square i frame due to settlement.

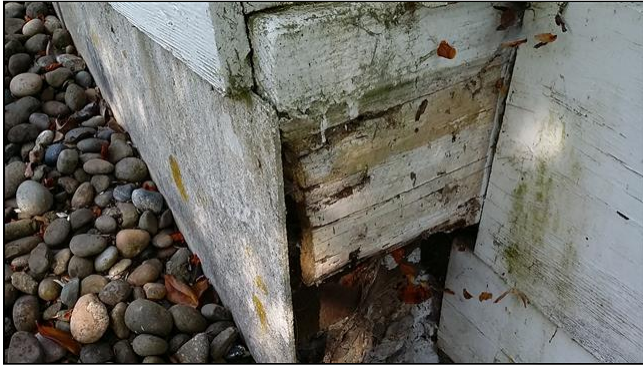
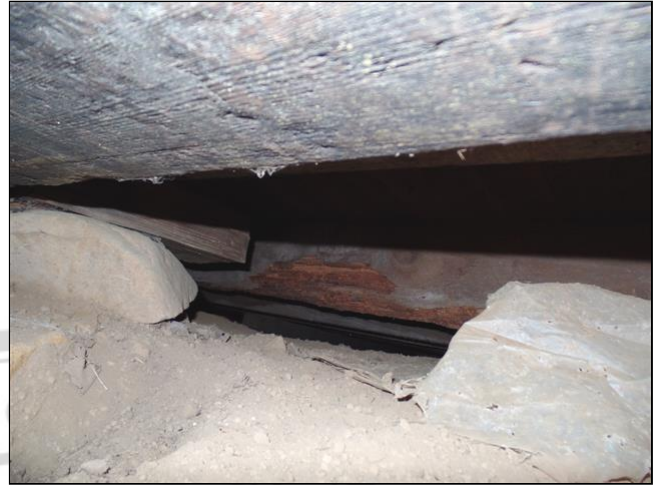
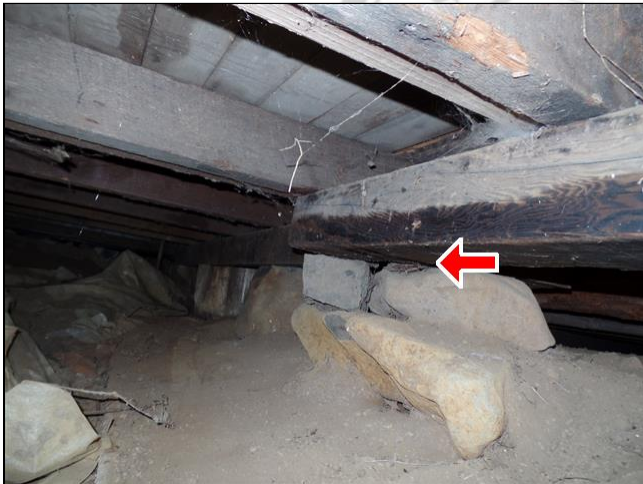
**4.1** This structure is pier,post and beam construction, It appears settlement and wood rot around the perimeter of the structure has occurred and is in need of repair. Recommend contacting a licensed contractor who specializes in these repairs.

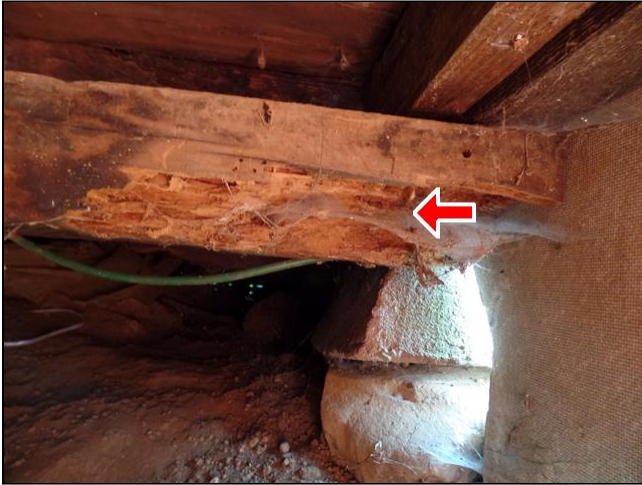
4.2 Floor structure support in crawlspace has moved, shifted and has some insect damage., This issue will result in uneven floors on the interior and will continue to move over time, A licensed contractor should be contacted to evaluate all floor support posts for all needed corrections.

4.2 Item 1(Picture) Wood destroying insect damage

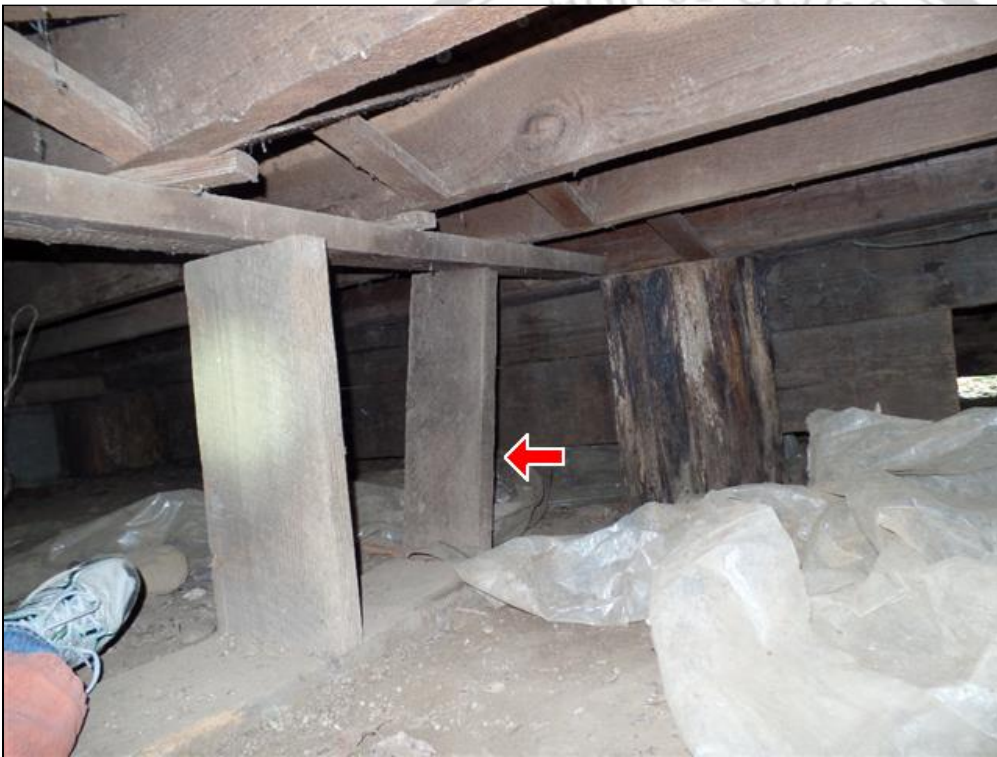
4.2 Item 2(Picture) Shifting support structure

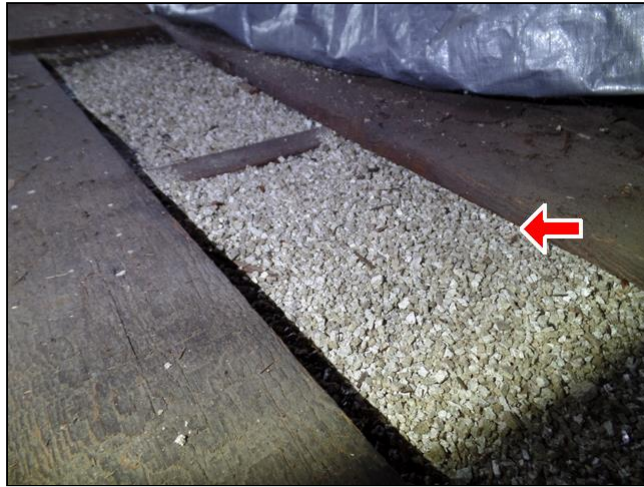
6.0 Item 1(Picture)

**6.0** Observed an insulation called vermiculite, Vermiculite insulation in most cases contains asbestos materials, This material should be tested for asbestos content and should not be touched or moved. A licensed contractor who is an expert in testing and removal is recommended

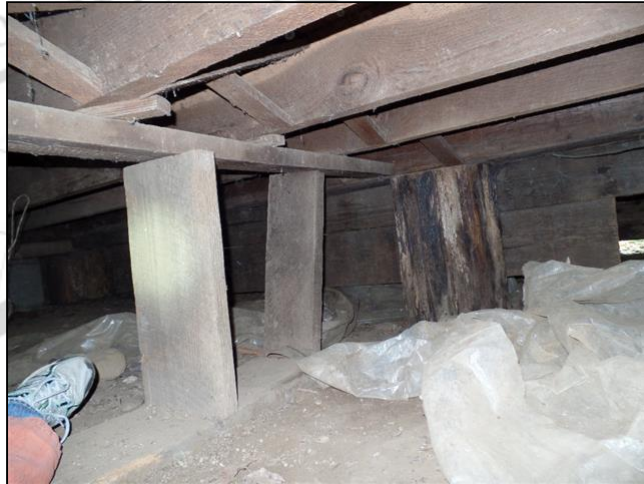
6.1 Item 1(Picture)

**6.1** The floor system is not insulated. Heat loss can occur more on this home than one that is properly insulated.

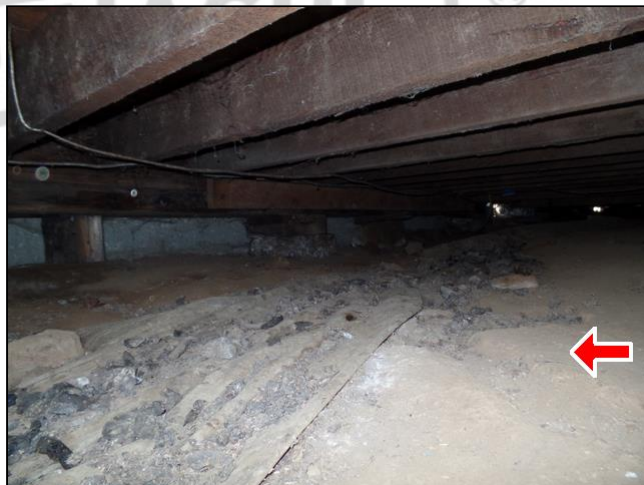
6.2 Item 1(Picture)

**6.2 (1)** The vapor barrier (plastic) on the crawlspace ground is missing in areas. A vapor barrier provides added protection to the floor system from moisture or dampness that can enter from ground. A qualified person should repair or replace as needed.

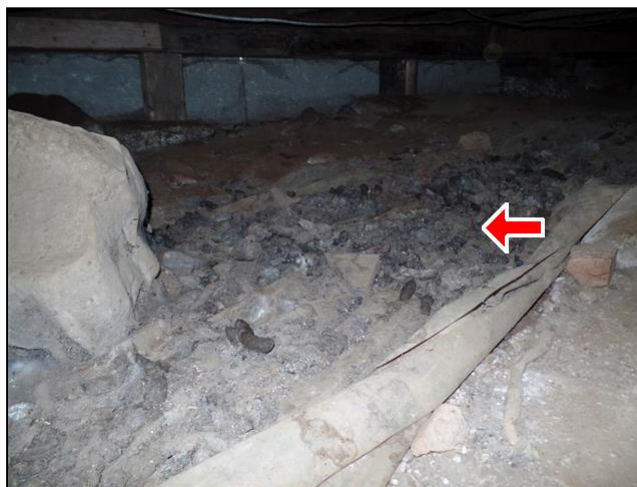
6.2 Item 2(Picture)

**6.2 (2)** Observed a large amount of animal dropping in crawlspace. This issue is unsanitary and should be corrected including animal access pont needs to be closed.

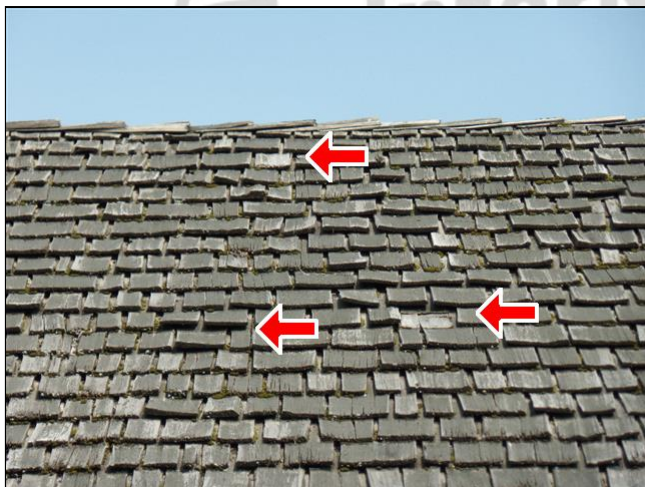
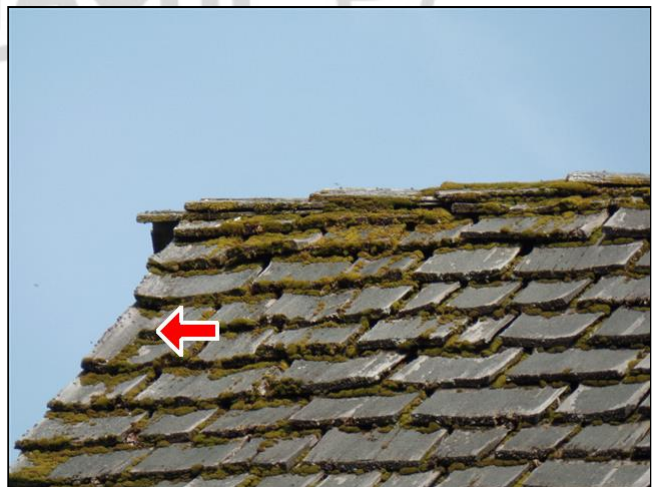
Wood shakes show deterioration including missing and curled shakes recommend a licensed roofing contractor evaluate entire roof for needed repairs

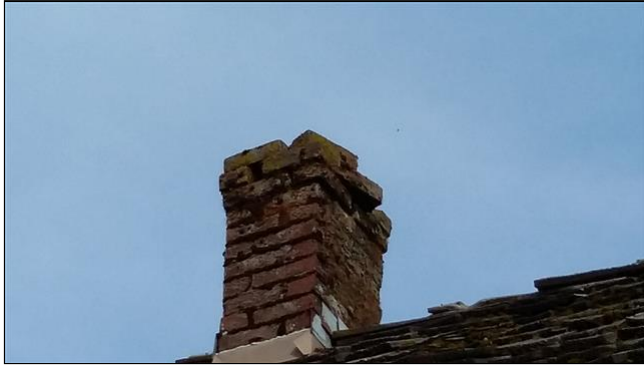
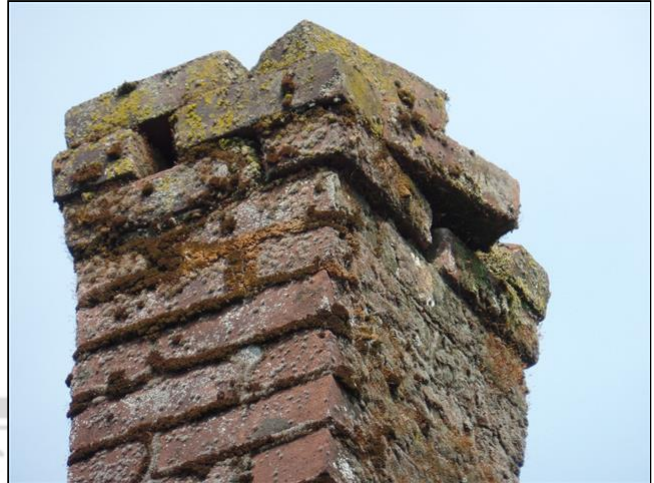
Chimney brick deterioration on both chimneys, chimney on West End of building unsafe and needs repair recommend a licensed chimney Contractor evaluate both chimneys for all needed repairs

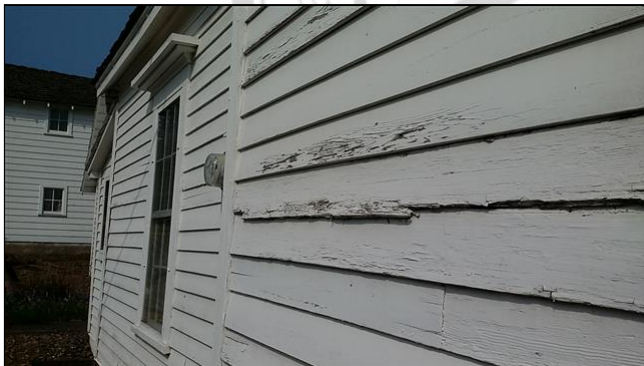
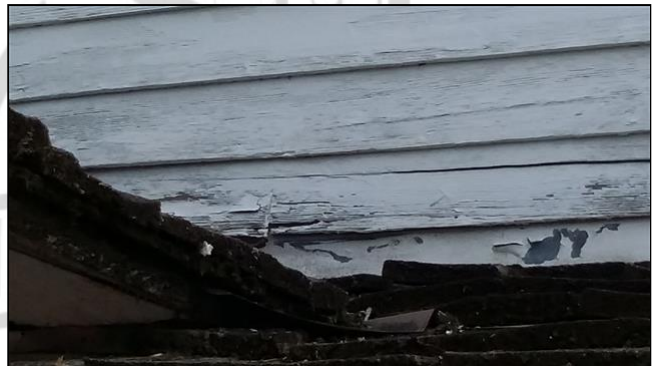
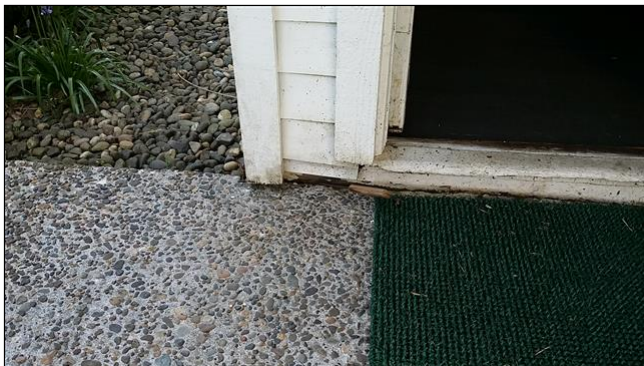
Horizontal wood siding shows deterioration mainly on south side of building recommend a licensed siding contractor evaluate for needed repairs or replacement

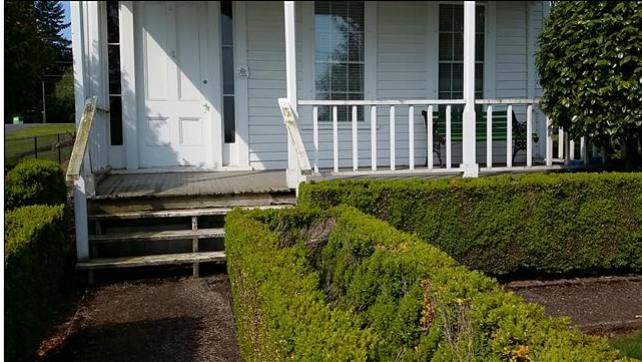
2.1 Item 1(Picture)

(1) Porch sloping to the southeast corner.

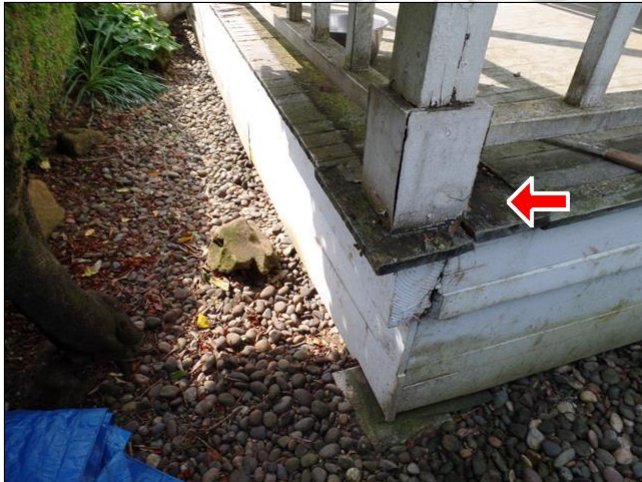
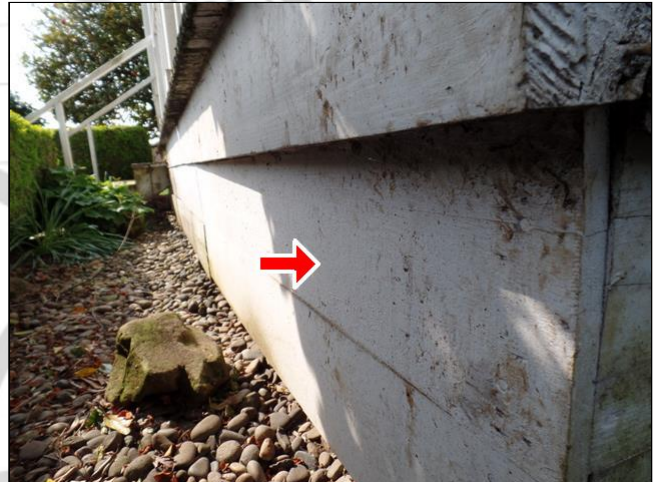
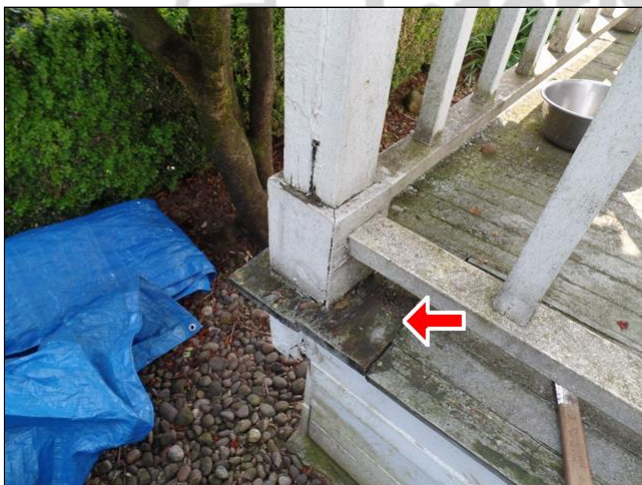
(2) Front porch and porch covering support post on right side(viewed from the front) has wood rot and floor movement. Lower portion of cladding appears to have settled under decking. This issue needs further inspection,evaluation and repair by a licensed contractor.

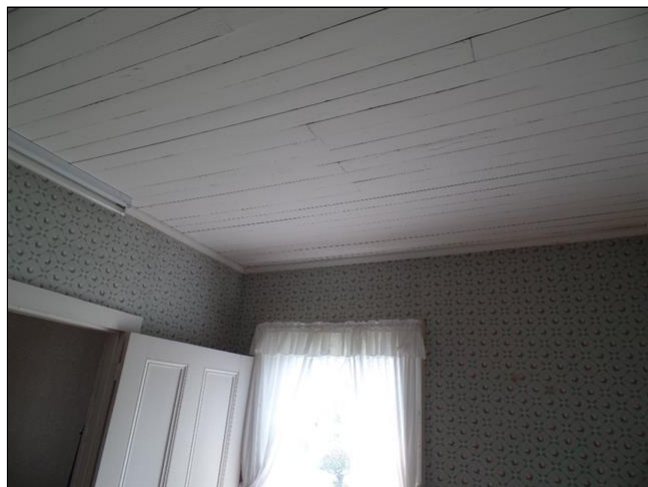
3.0 Item 1(Picture)

Noted a large amount of ceiling movement(sagging) viewed from the main floor. I am unable to determine the cause of this issue therefore a licensed contractor needs to evaluate for all needed repairs.

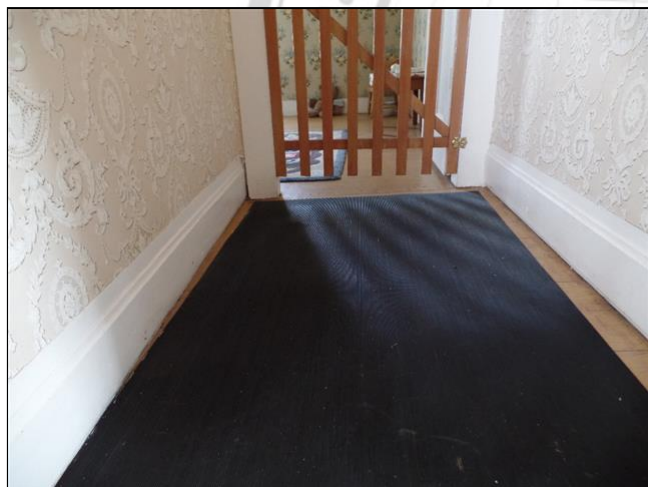
3.2 Item 1(Picture)

Slopping floor structure due to settlement, Recommend a licensed contractor evaluate for all needed repairs.

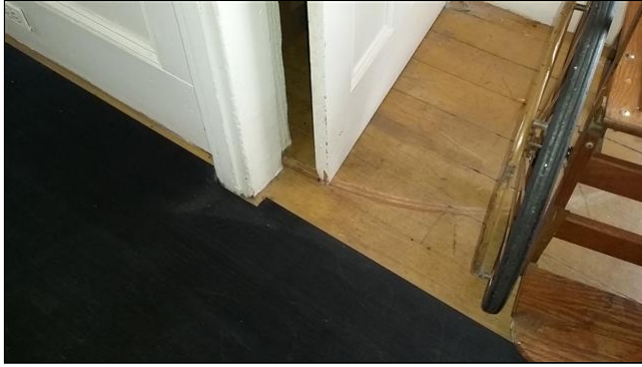
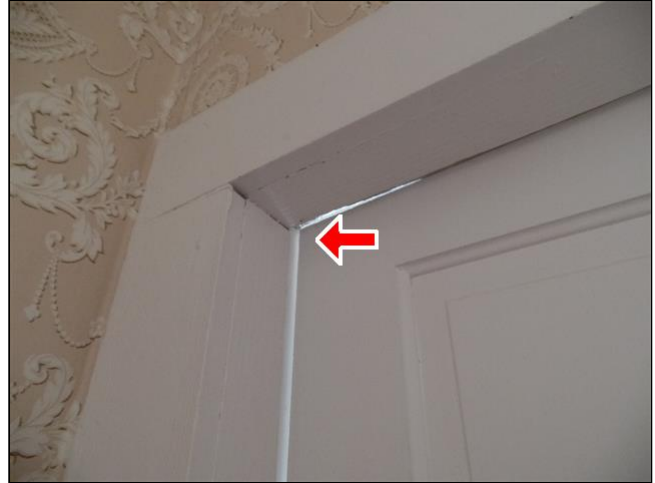
Many doors are out of square i frame due to settlement.

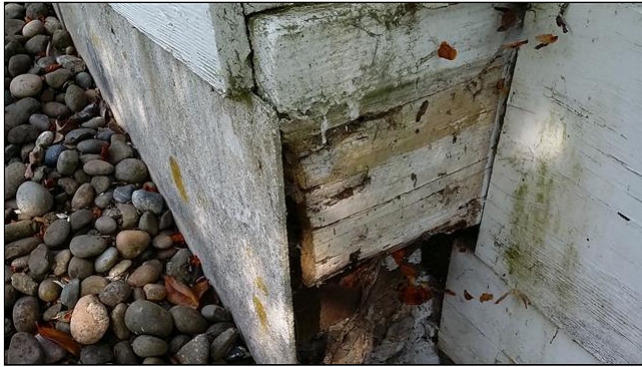
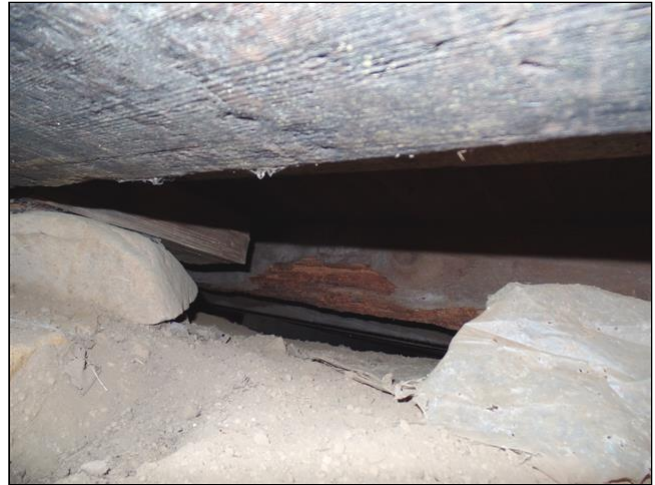
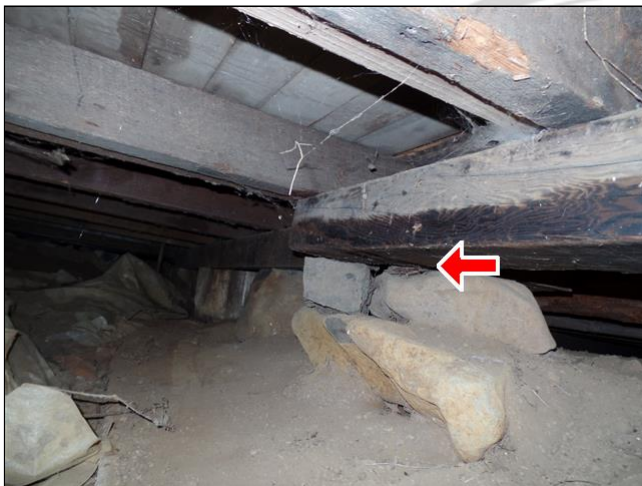
This structure is pier, post and beam construction, It appears settlement and wood rot around the perimeter of the structure has occurred and is in need of repair. Recommend contacting a licensed contractor who specializes in these repairs.

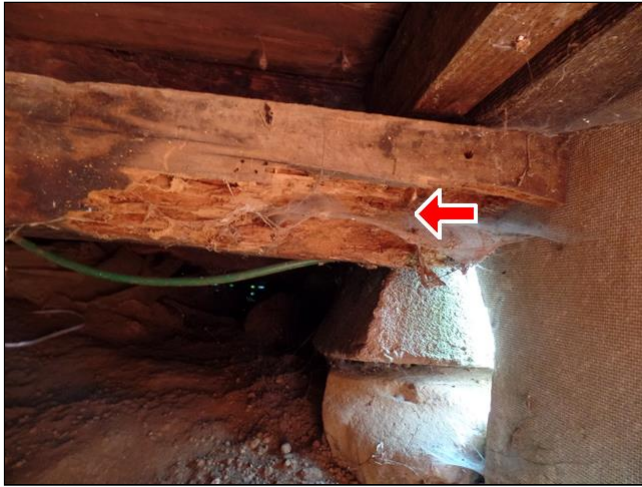
Floor structure support in crawlspace has moved, shifted and has some insect damage., This issue will result in uneven floors on the interior and will continue to move over time, A licensed contractor should be contacted to evaluate all floor support posts for all needed corrections.

4.2 Item 1(Picture) Wood destroying insect damage

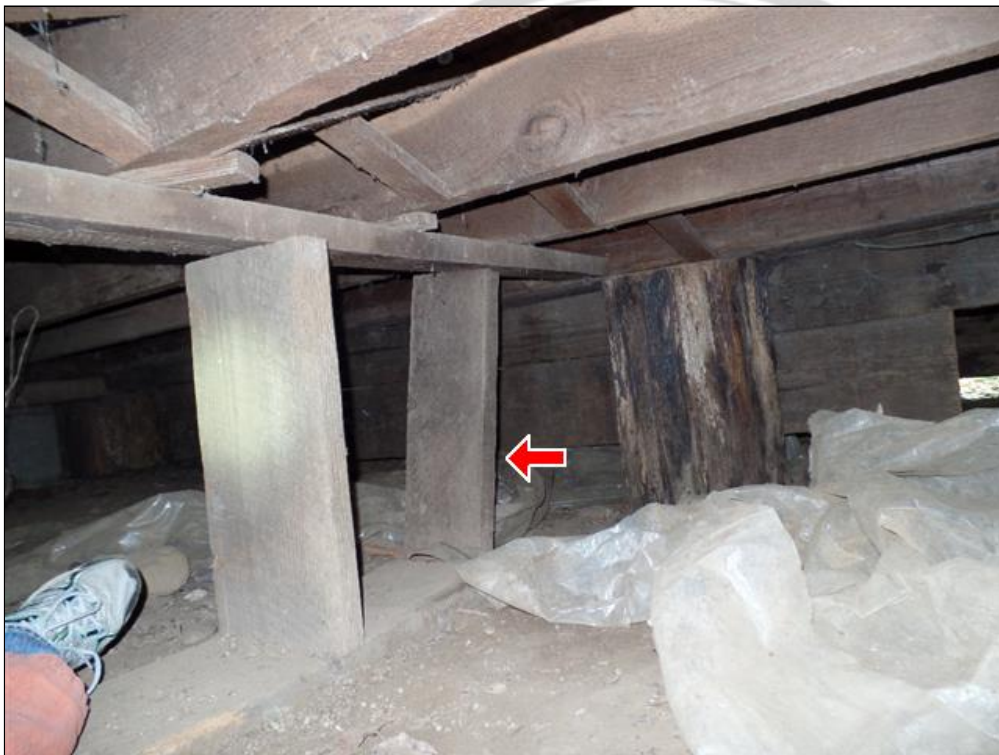
4.2 Item 2(Picture) Shifting support structure

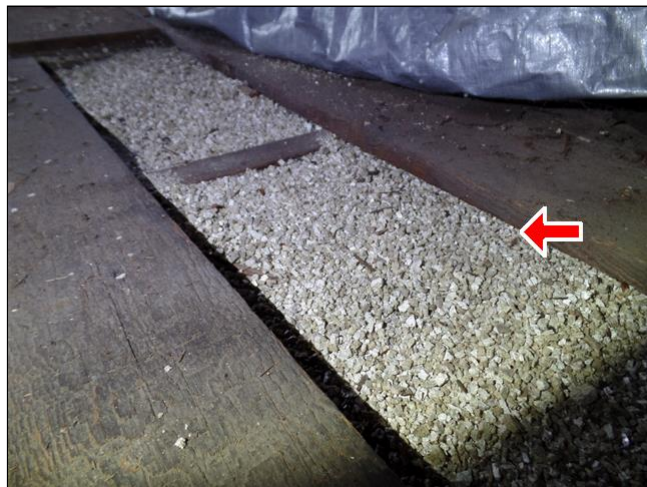
6.0 Item 1(Picture)

Observed an insulation called vermiculite, Vermiculite insulation in most cases contains asbestos materials, This material should be tested for asbestos content and should not be touched or moved. A licensed contractor who is an expert in testing and removal is recommended

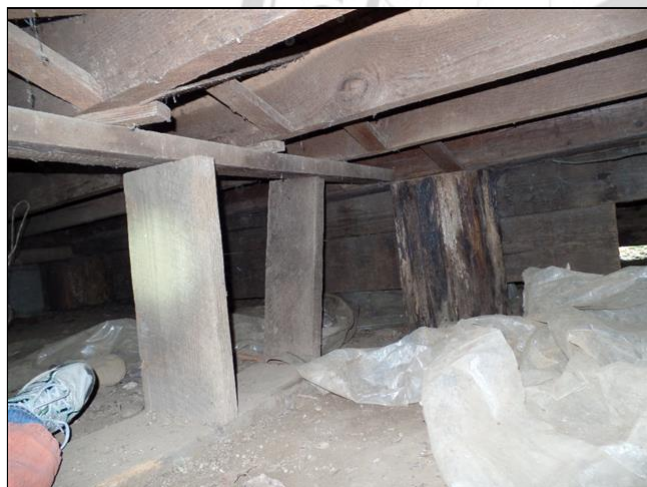
6.1 Item 1(Picture)

The floor system is not insulated. Heat loss can occur more on this home than one that is properly insulated.

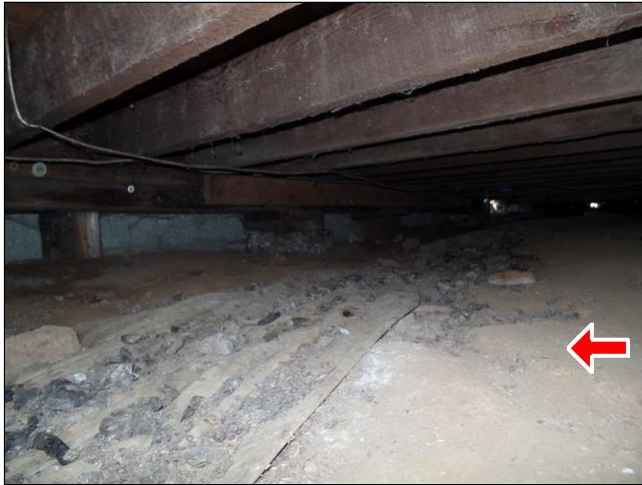
6.2 Item 1(Picture)

(1) The vapor barrier (plastic) on the crawlspace ground is missing in areas. A vapor barrier provides added protection to the floor system from moisture or dampness that can enter from ground. A qualified person should repair or replace as needed.

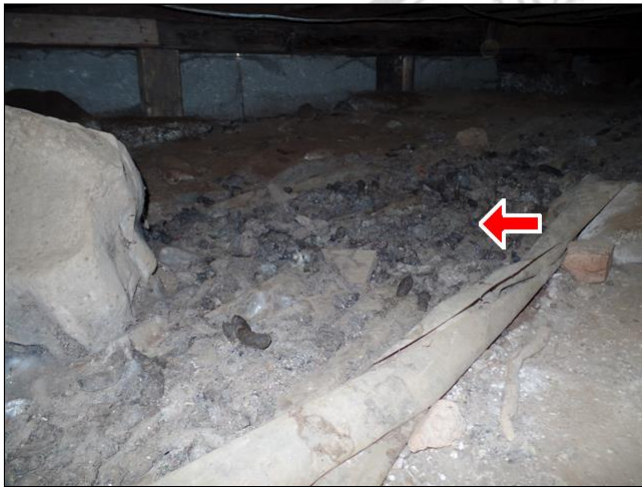
6.2 Item 2(Picture)

(2) Observed a large amount of animal droppings in crawlspace. This issue is unsanitary and should be corrected including animal access point needs to be closed.
